Pacific Gas and Electric Company
Natural Gas Transmission Pipeline Rupture and Fire
San Bruno, California
September 9, 2010

NTSB/PAR-11/01
PB2011-916501

Pipeline Accident Report

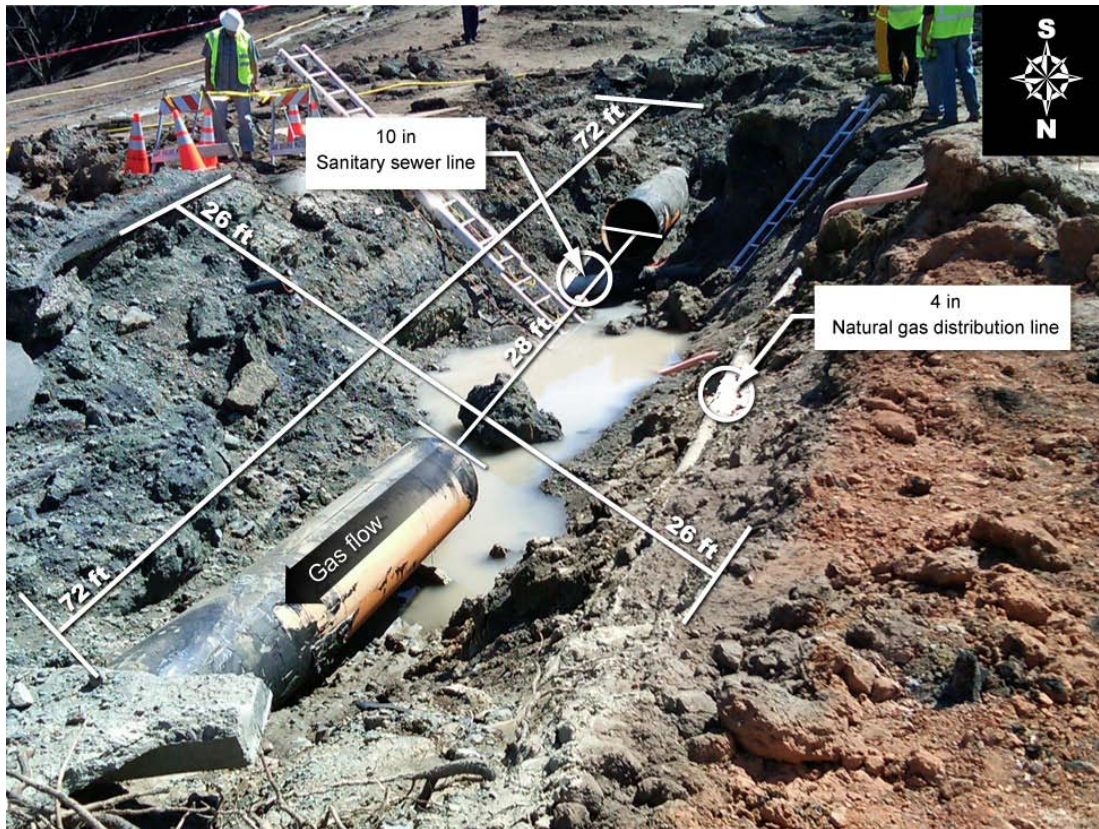
Figure 1. Picture of crater and ruptured pipeline.

On September 9, 2010, about 6:11 p.m. Pacific daylight time,¹ a 30-inch-diameter segment of an intrastate natural gas transmission² pipeline known as Line 132, owned and operated by the Pacific Gas and Electric Company (PG&E), ruptured in a residential area in San Bruno, California. The rupture occurred at mile point (MP) 39.28 of Line 132,³ at the intersection of Earl Avenue and Glenview Drive. The rupture produced a crater about 72 feet long by 26 feet wide. (See figure 1.) The section of pipe that ruptured, which was about 28 feet long, and weighed about 3,000 pounds, was found 100 feet south of the crater. (See figure 2.) PG&E estimated that 47.6 million standard cubic feet of natural gas was released. The released natural gas ignited, resulting in a fire that destroyed 38 homes and damaged 70. (See figure 3.) Eight people were killed, many were injured, and many more were evacuated from the area.

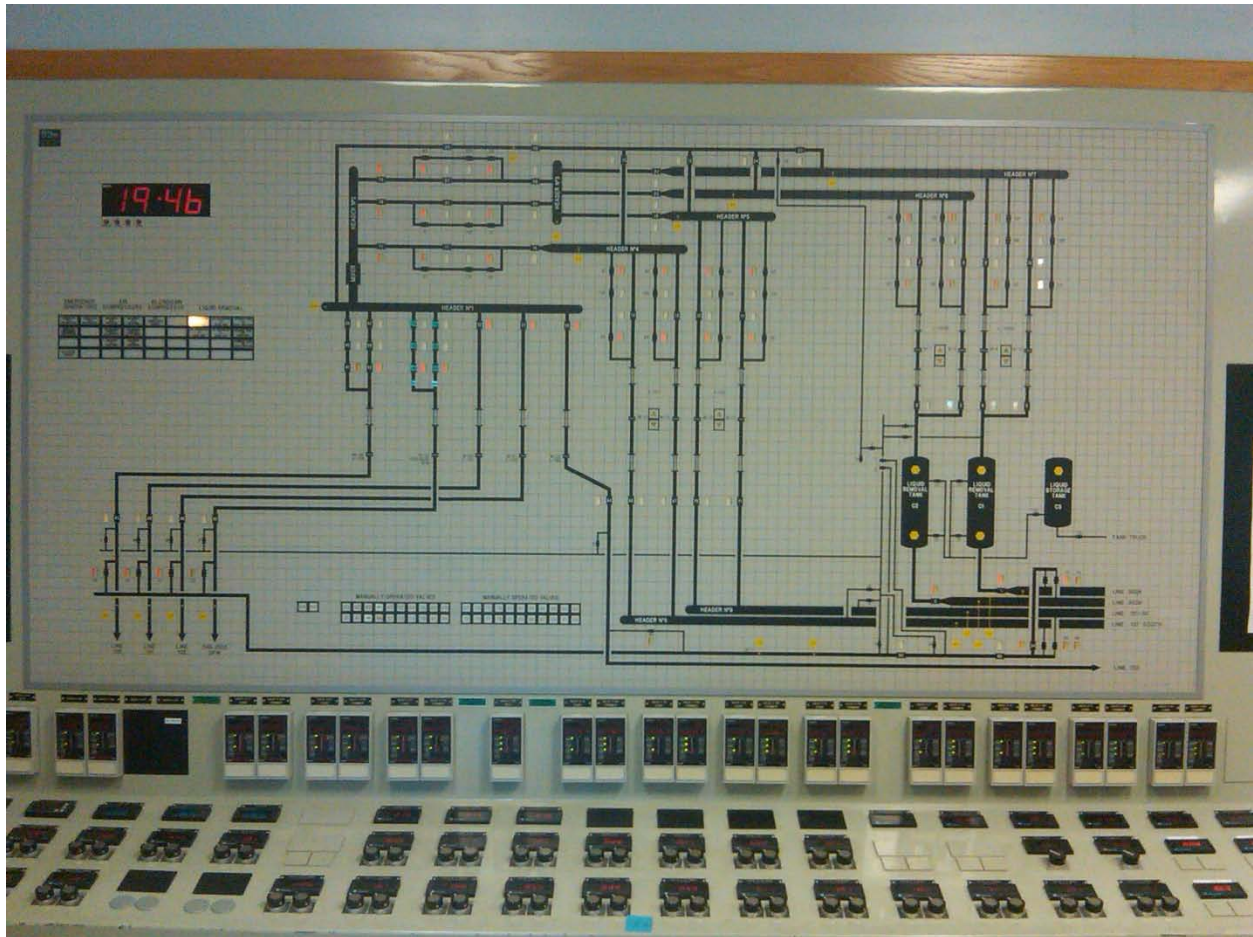
Figure 5. Picture of local control panel.

Following the transfer of critical loads from the UPS panel, workers at the Milpitas Terminal began to remove power from an unidentified breaker. During that work, the workers opened a circuit that resulted in a local control panel unexpectedly losing power. (See figure 5.) Rather than reenergizing the circuit, the workers pulled drawings and began investigating how to power the local control panel from an alternate source. One of the technicians stated in a postaccident interview that while measuring electrical currents with a clamp-on amp meter, the workers noticed some of the displays at the local control panel went blank. Subsequent troubleshooting showed this to be the result of erratic output voltages from two redundant 24-volt d.c. power supplies (power supplies A and B on figures 6a and 6b). These
